**Fire Resistance Testing of "PURBOND HB  
E032 (3074-3)" Adhesive in Accordance With  
the AF&PA Elevated-Temperature Adhesive  
Qualification Procedure**

**WFCi Report #08019**

**Conducted On: April 3, 2008**

**Report Issued On: April 18, 2008**

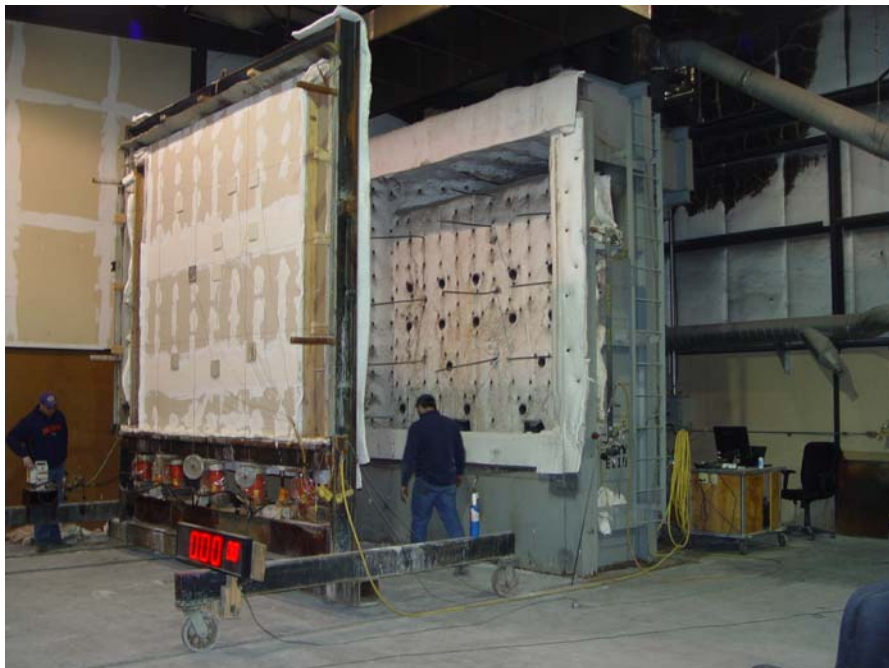
The furnace used in the test is a large-scale fire burning apparatus, fueled by natural gas (pictured below). The furnace is mounted to the floor, with the back side close to the west wall, at the south end of the laboratory facility. Inside the laboratory to the north of the furnace is a large area for specimen construction and curing. Ambient temperature in the laboratory is controlled by natural gas radiant heaters at the ceiling level.

The wall section is mounted in a vertical orientation into a steel frame specimen holder. The specimen holder is then rolled up to the furnace and secured by four pneumatic rams to the furnace opening. Combustion air and natural gas are supplied to burners through a series of pipes and valves. Internal furnace pressure is controlled by a series of dampers in the exhaust outlets. Temperature measurements are recorded by calibrated data acquisition units which pass the readings to a computer for graphical display and storage. A large roll up door is in the wall opposite the furnace area and allows for the samples to be moved approximately 40' on tracks outdoors to the area designated for hose stream testing.

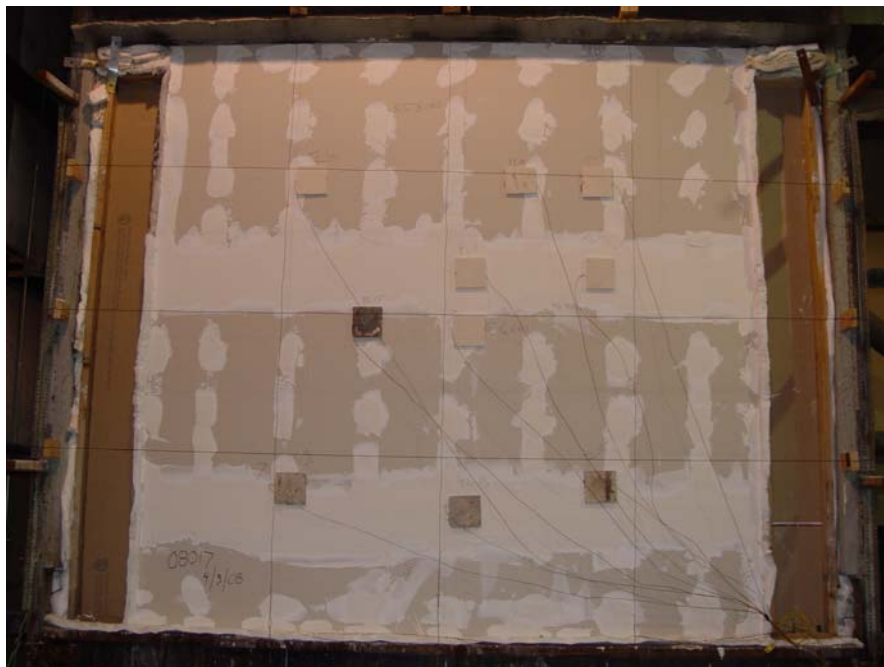
**Figure 1. Unexposed Thermocouple Locations (North to the right)**

Thermocouples 6-14 were arrayed on the unexposed surface as depicted in Figure 1. Each thermocouple was placed within approximately 1-1/2 in. from the vertical supporting elements.

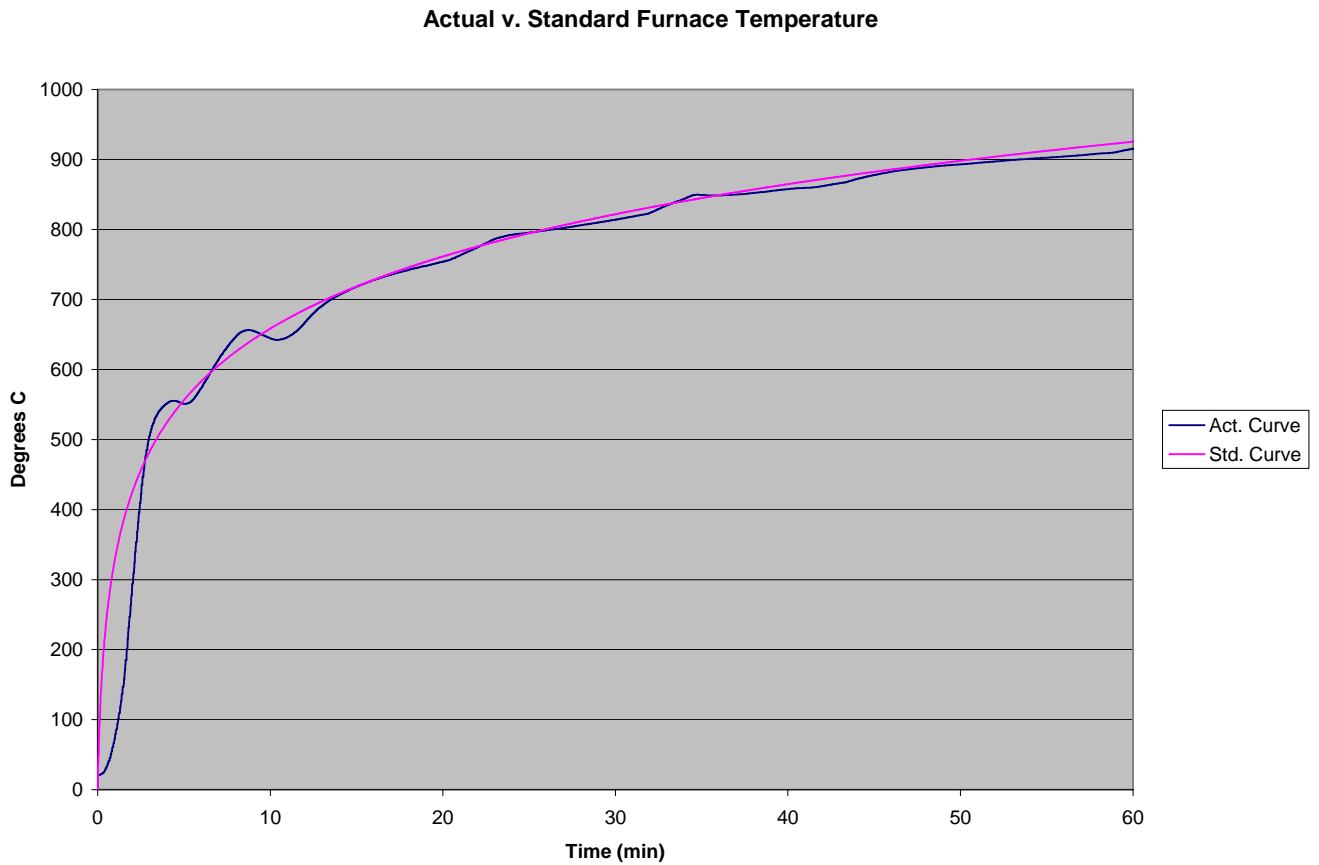
## Furnace Temperatures

The area under the actual time-temperature curve was determined to be within 1% of standard. The required area under the standard time-temperature curve is **45,740 deg. C-minutes**, and the area under the actual curve was **45,421 deg. C-minutes**.

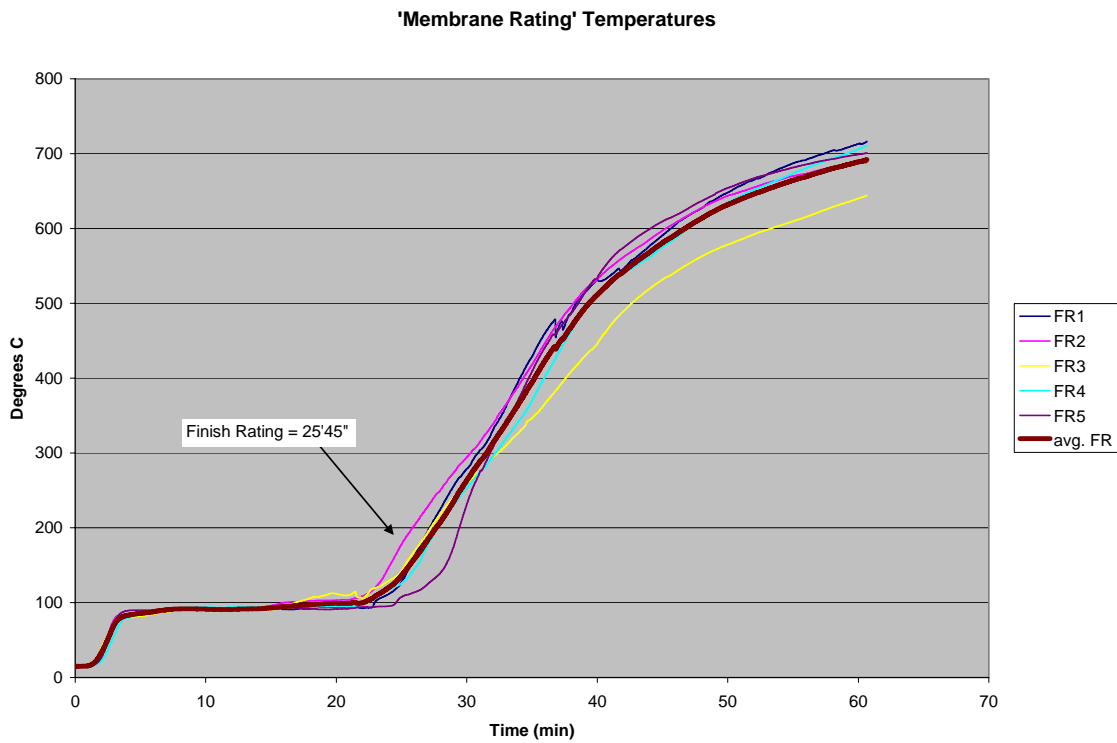
## Membrane Rating Thermocouple Temperatures

Thermocouples 1-5 were placed on the exposed (furnace) side of the wood studs beneath the base layer of GWB to obtain finish rating data during the test.

Average: 139°C + Ambient

Individual: 181°C + Ambient

Individual: 25:45, TC#2 (upper S Qtr.Pt.)

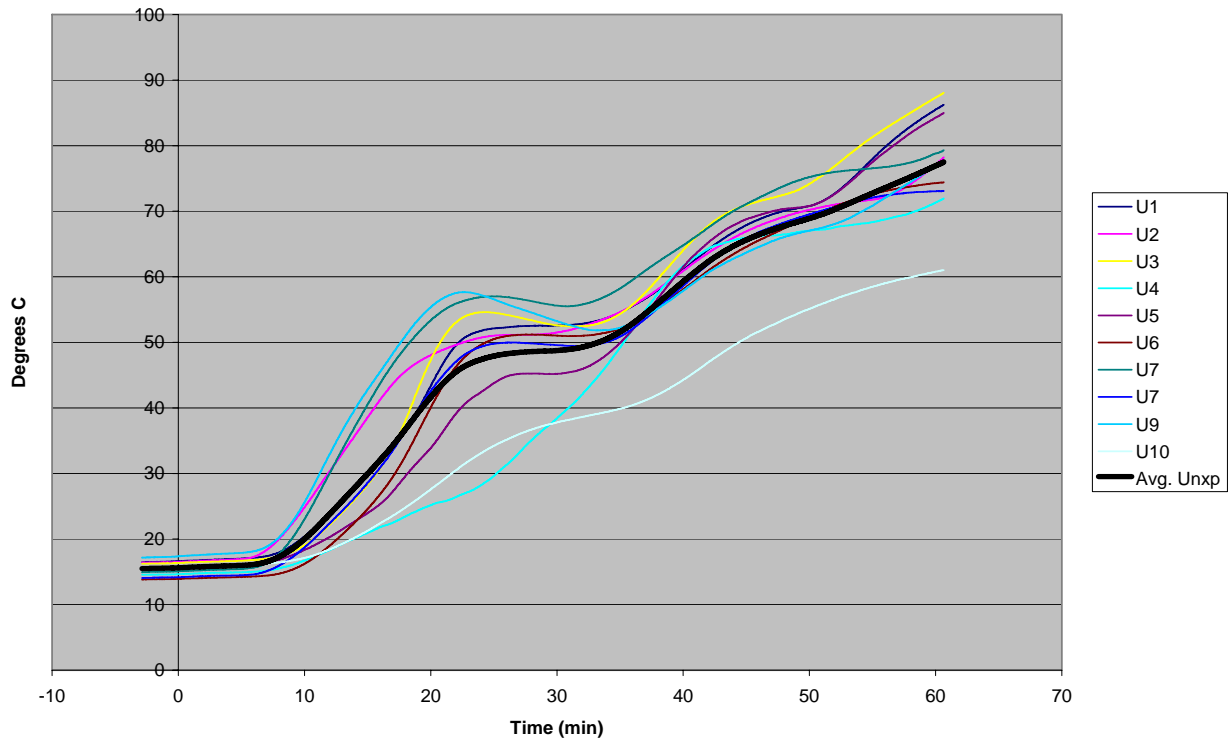
Unexposed Surface Temperatures

Average: 139°C + Ambient

Individual: 181°C + Ambient

Individual: N/A (TC No. N/A)

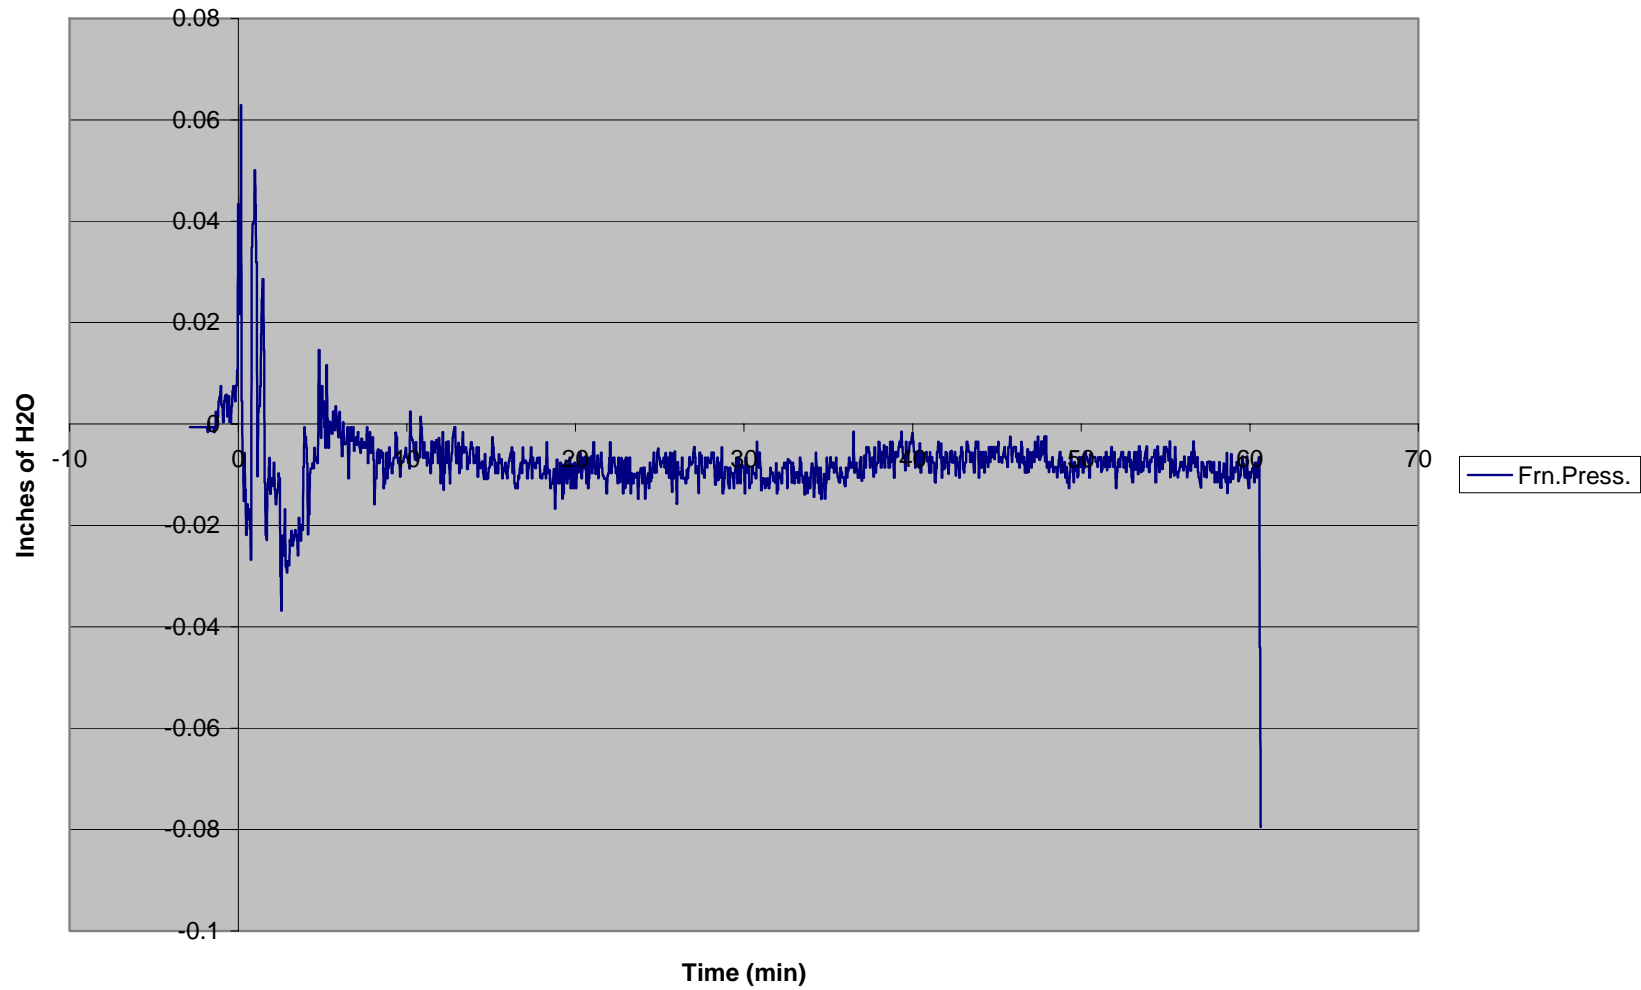
### Graph 1: Furnace Pressure at Top of Wall

-The neutral pressure plane was located near the top of the wall assembly.

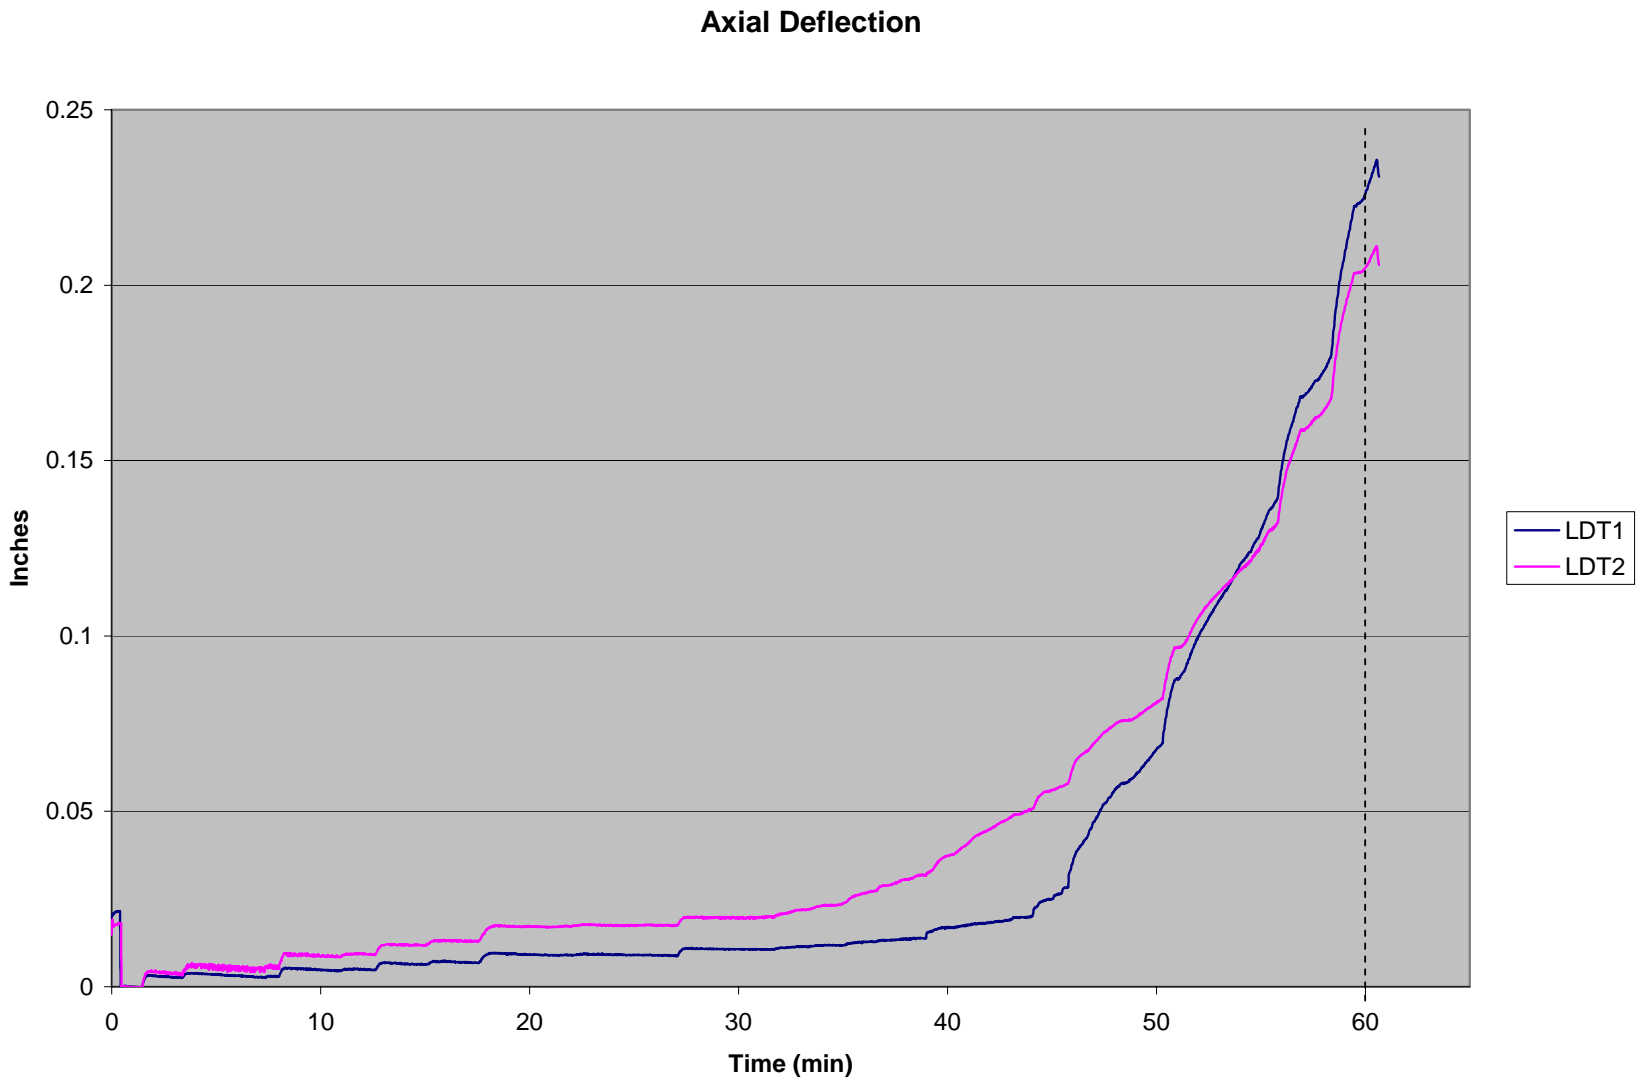
### Graph 2: Sample Displacement

During the test, horizontal deflection measurements (Table 2) were taken every five minutes at five locations on the unexposed sample surface to monitor horizontal movement and/or buckling of the sample. Vertical (axial) deflection was recorded by two linear displacement transducers placed at each end of the load beam and recorded continuously. Vertical deflection is reported graphically in Appendix A.

- The wall assembly supported the applied load for the **full 60 minute fire test duration**.
- Maximum horizontal deflection: **2.25 inches**
- Maximum vertical deflection: **0.23 inches**
- Finish (Membrane Protection) Rating: **25 minutes, 45 seconds**.
- Temperatures on the unexposed face remained within the allowed single-point temperature rise of 181°C (325°F) above the starting temperature throughout the test.
- The average temperature rise for the unexposed face thermocouples remained within the allowable limit of 139°C (250°F) above the starting temperature throughout the test.

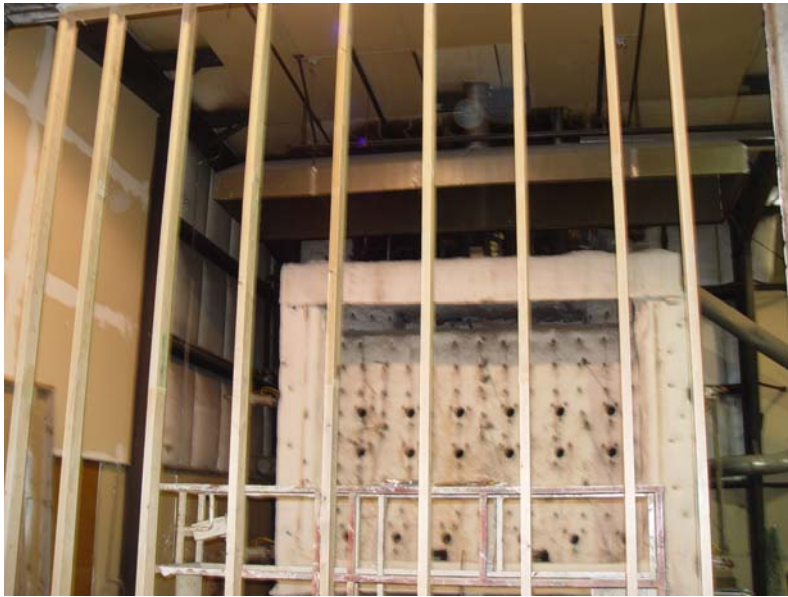
The 10' wide x 10' high wall sample was constructed in strict accordance with the specifications detailed in the "Elevated-Temperature Adhesive Qualification Procedure (ETAQP)". The assembly consisted of nominal 2x4-in. Douglas fir end-jointed lumber spaced 16-in. O.C. (12" O.C. between first two and last two studs), with each stud containing a finger-joint located in the center third of the stud length. A single top plate and two bottom plates were used in the wall construction. The external faces of the wall were each covered with one layer of 5/8" type X gypsum wallboard (GWB) mounted horizontally on both sides (perpendicular to the supporting elements). The GWB joints on each side were covered with paper tape and gypsum joint compound in the standard manner. The screw heads were also covered with joint compound. Mineral wool batt insulation, 3-1/2" thick, nominal 2.5 PCF density, was cut to width and friction-fit in each stud cavity.

**Sample construction: wood studs**

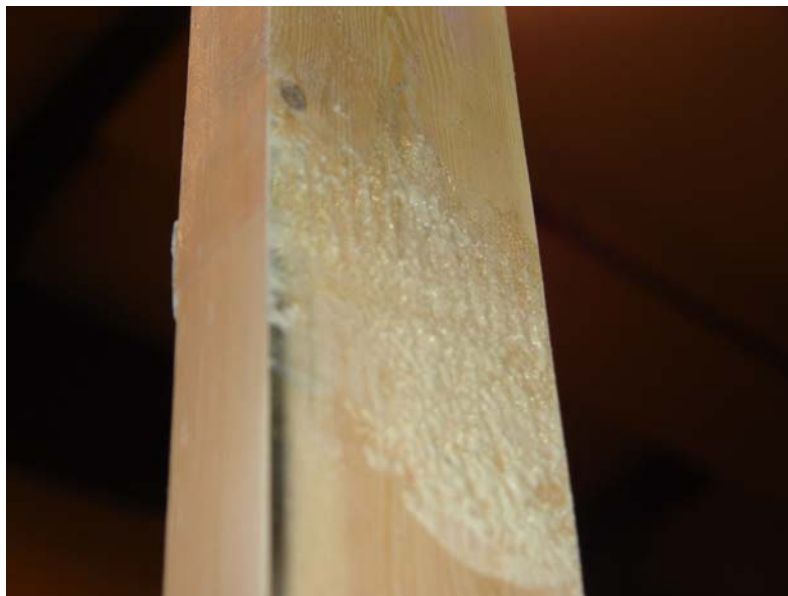
**Wood Framing:** Nominal 2 in. by 4 in. finger-jointed Select Structural Douglas fir lumber bearing the grade stamp of a nationally recognized grading agency (CMSA) were provided by the client on March 31, 2008. The studs had an average moisture content of approximately 11% percent (ranging from 9 to 12%) prior to application of the GWB on the test wall (as measured by an electrical resistance moisture meter). The weight of the vertical wood studs averaged 15.2 (+/- 1.0) lbs. There was a single finger-joint in each stud. The finger-joints were located within the middle third of the length of each stud, 43 in. and 80 in. from the base of the wall assembly, alternating the location to adjacent studs. The finger-joint length was 1-1/8" and the joint orientation was vertical. See photographs in Appendix B for depiction of finger-joint.

**Finger-joint**

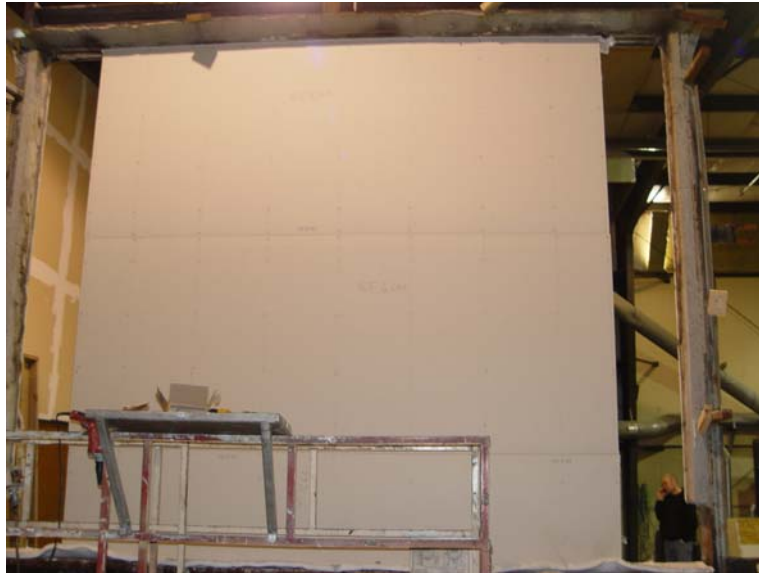
**Gypsum Wallboard (GWB):** Single layer 4' wide x 10' long UL labeled GP-Gypsum Tough Rock<sup>®</sup> Fireguard<sup>®</sup> 5/8" type X gypsum wallboard, with an average unit weight of 2150 lbs/MSF (as determined by WFCi). The wallboard was applied horizontally (perpendicular to studs) and fastened 12 in. OC in accordance with the referenced test protocol. For the exposed surface, two 4 x 10' pieces were attached starting at the base of the wall, followed by a 2' x 10' piece finishing the top of the wall. On the unexposed side, the 2' x 10' piece was attached at the base of the wall, followed by the two 4' x 10' pieces. There were no vertical joints in the wallboard. Paper tape and joint compound was applied to fastener heads and joints on the faces of the exposed and unexposed sides in the standard manner.

**Sample construction, addition of GWB**

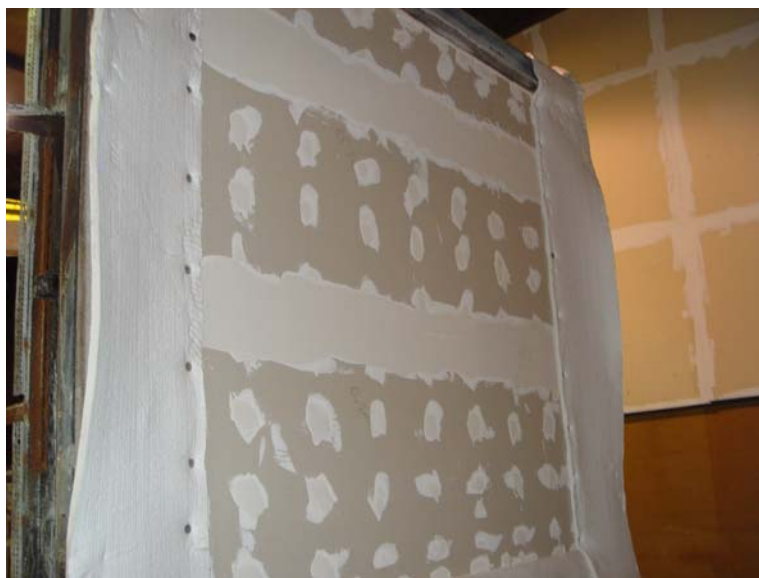
**Sample construction: exposed face**

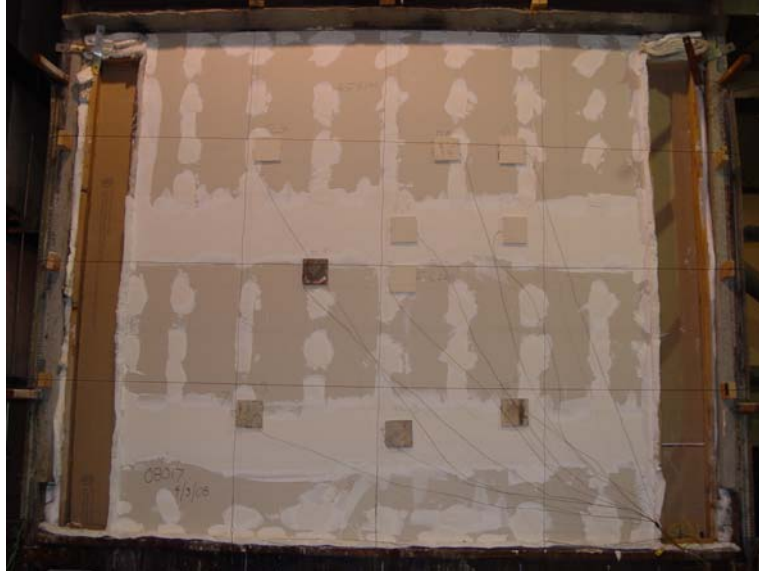
**Sample construction: unexposed face**

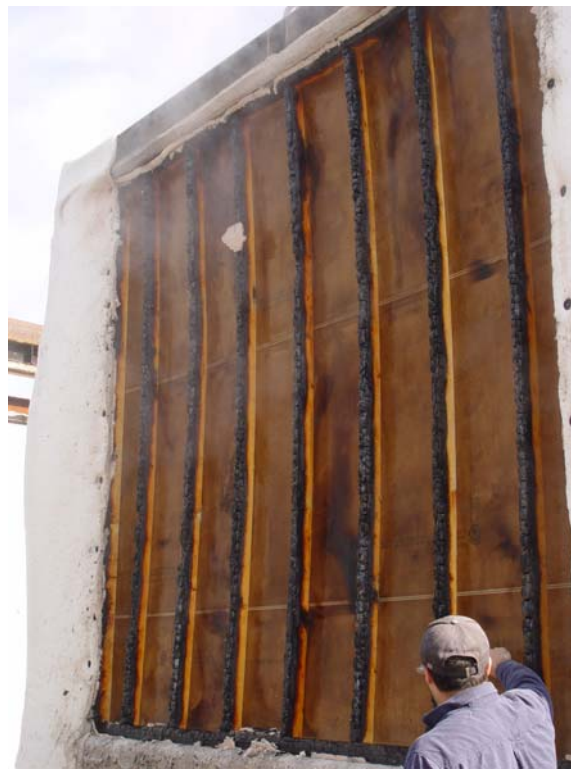
**Post exposure, cavity exposed**

Following the test, the test assembly was detached from the furnace and the fire extinguished. Upon removal of the wallboard and cavity insulation, the studs were visually evaluated. No evidence of finger-joint failure was observed. The wood studs exhibited charring to approximately 25% of the stud depth on the fire exposed side, and all studs were consistent in appearance. All studs were evenly bowed outward (away from the fire exposure) along their length; no fracturing or other signs of breakage were noted. See photographs provided in Appendix B.

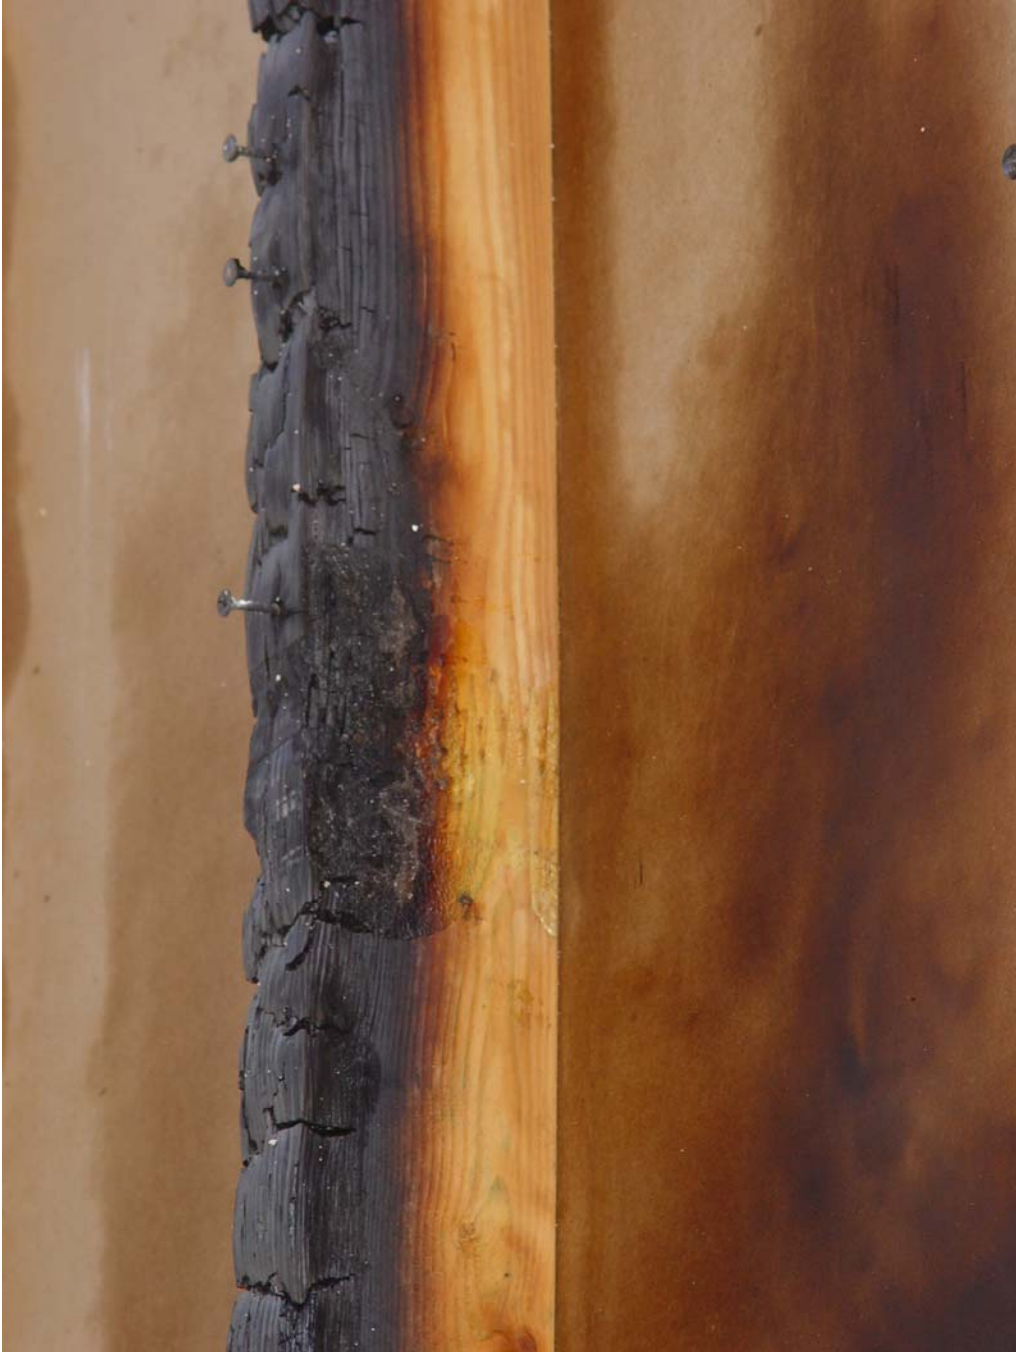
**Charred stud at finger-joint**
